Quality Assurance and Source Inspection

Contract #: 04-0120F4Cty: SF/ALA Rte: 80 PM: 13.2/13.9File #: 1.28**WELDING INSPECTION REPORT****Resident Engineer:** Casey, William**Address:** 333 Burma Road**City:** Oakland, CA 94607**Report No:** WIR-026670**Date Inspected:** 08-Nov-2011**Project Name:** SAS Superstructure**OSM Arrival Time:** 700**Prime Contractor:** American Bridge/Fluor Enterprises, a JV**OSM Departure Time:** 1730**Contractor:** American Bridge/Fluor Enterprises, a JV**Location:** Jobsite**CWI Name:** As noted below**CWI Present:** Yes No**Inspected CWI report:** Yes No N/A**Rod Oven in Use:** Yes No N/A**Electrode to specification:** Yes No N/A**Weld Procedures Followed:** Yes No N/A**Qualified Welders:** Yes No N/A**Verified Joint Fit-up:** Yes No N/A**Approved Drawings:** Yes No N/A**Approved WPS:** Yes No N/A**Delayed / Cancelled:** Yes No N/A**Bridge No:** 34-0006**Component:** SAS OBG**Summary of Items Observed:**

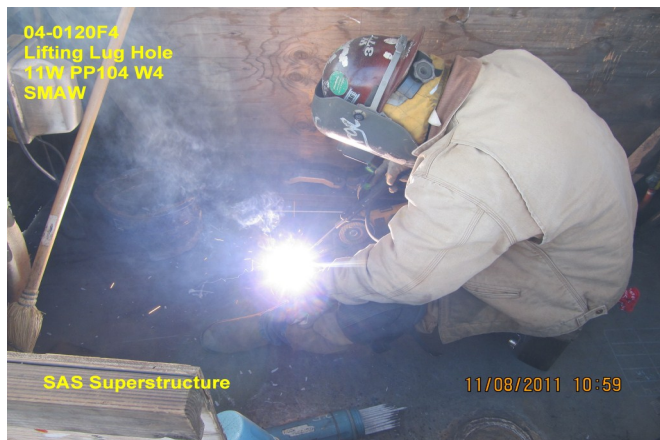
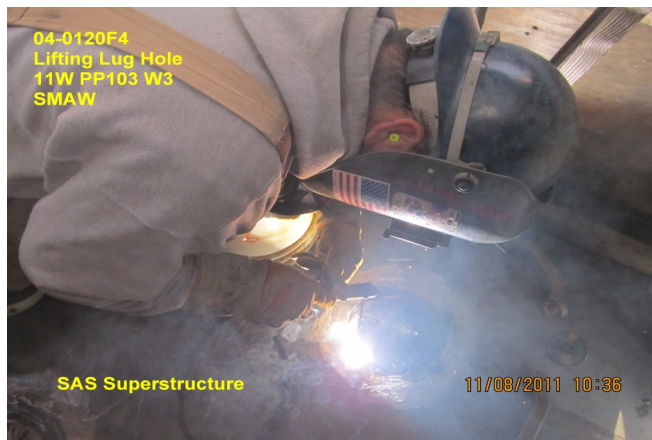
The QA inspector made random observations of ABF welder Jorge Lopez, ID# 6149 performing Shielded Metal Arc Welding (SMAW) in the 1G flat position on Lifting Lug Hole (LLH) #4 located at 11W PP104 W4. The QA inspector observed QC inspector Sal Merino monitoring the progress to ensure the welding parameters was in compliance pertaining to ABF-WPS-D15-1050A-CU. The parameters were recorded as (Amperes=130). The QA inspector made subsequent observations throughout the shift to monitor quality. The QA inspector noted that the work on the exterior side of the LLH was completed on this date and appeared to be in general conformance with the contract documents.

performing SMAW in the 1G flat position on LLH #2 located at 11W PP103 W3. The QA inspector observed the QC inspector identified as Sal Merino measure the joint fit-up and found it to be acceptable and within compliance. The QA inspector observed the QC inspector monitoring the progress to ensure the welding parameters were in compliance pertaining to ABF-WPS-D15-1050A-CU. The parameters were recorded as (Amperes=180). The QA inspector randomly observed the ABF welder grind and blend the start and stop areas of the weld throughout the joints depth. The QA inspector made subsequent observations throughout the shift to monitor quality and noted that the work on the exterior side of the LLH was completed on this date and appeared to be in general conformance with the contract documents.

The QA inspector observed QC inspector Sal Merino measure the planar offset and the root gap of LLH #4 insert located at 11W PP103 W3 and verified that the results were in compliance. The QA inspector observed ABF welder Mike Jimenez ID #4671 preheat the joint to 50°F and began welding utilizing the SMAW method in the 1G flat position. The welder began with 1/8 inch diameter E7018H4R electrodes at 145 amperes for the root pass and the balance with 3/16 inch diameter electrodes at 190 amperes. The QA inspector observed the QC inspector monitoring the progress to ensure the welding parameters was in compliance pertaining to ABF-WPS-D15-1050A-CU. The QA inspector made subsequent observations throughout the shift to monitor quality and noted that the work was completed on this date and appeared to be in general conformance with the contract documents.

The QA inspector observed the QC inspector Pat Swain, verify the fit up of the joint and found it to be satisfactory. The QA inspector made random observations of ABF welder Jorge Lopez, ID# 6149 performing Shielded Metal Arc Welding (SMAW) in the 1G flat position on Lifting Lug Hole (LLH) #1 located at 14W PP128 W4. The QA inspector observed QC inspector monitoring the progress to ensure the welding parameters was in compliance pertaining to ABF-WPS-D15-1050A-CU. The parameters were recorded as (Amperes=135). The QA inspector made subsequent observations throughout the shift to monitor quality. The QA inspector noted that the work on the exterior side of the LLH was in progress and appeared to be in general conformance with the contract documents.
